CONNECTICUT RIVER BASIN
COLRAIN, MASSACHUSETTS

McLEOD POND DAM
MA 00046

PHASE I INSPECTION REPORT
NATIONAL DAM INSPECTION PROGRAM

NOVEMBER 1978

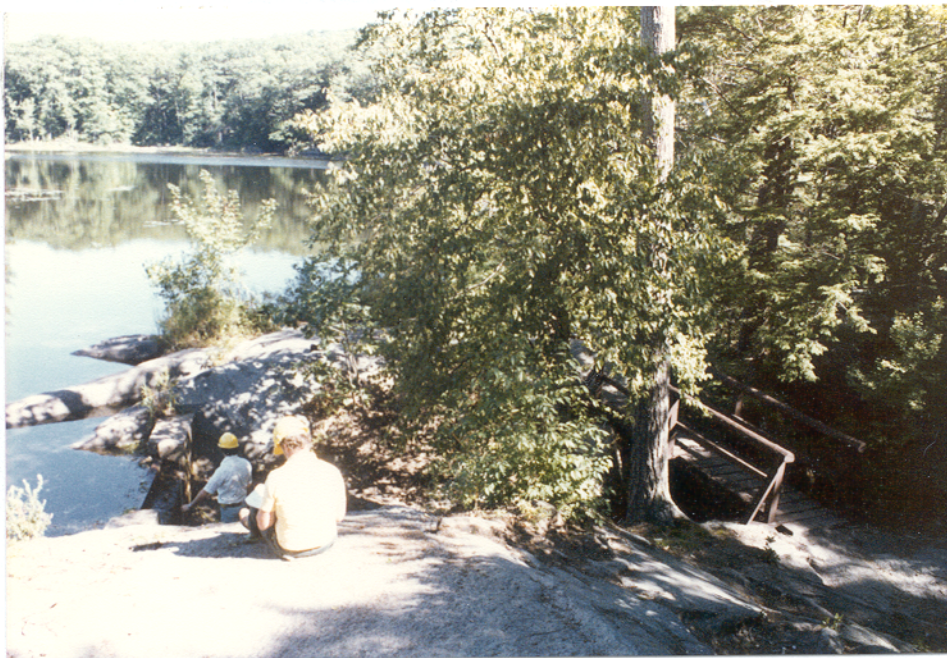
1. OVERVIEW OF DAM, SPILLWAY AND FOOTBRIDGE FROM
RIGHT ABUTMENT

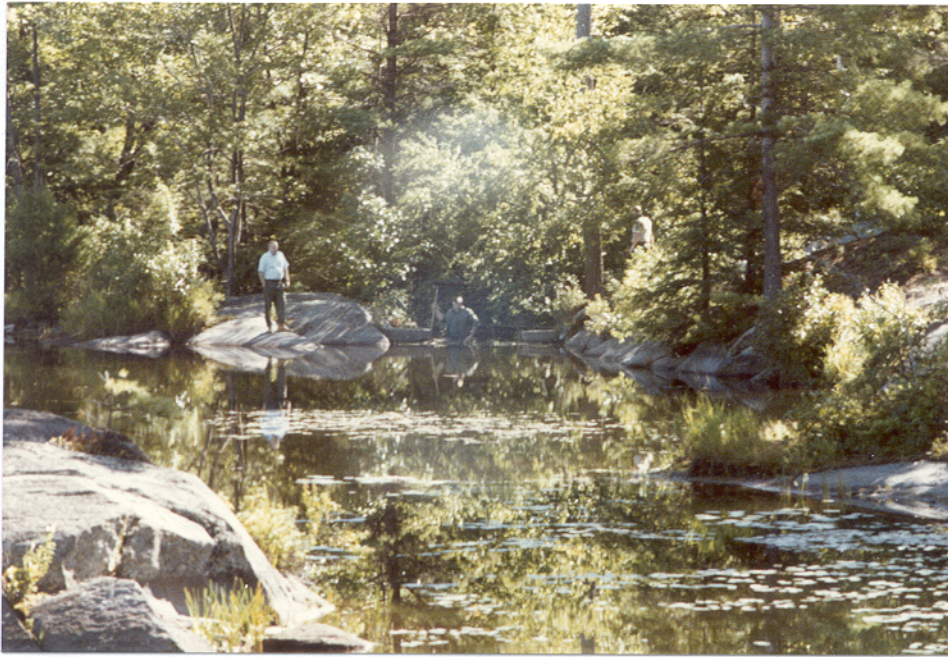
2. TELEPHOTO VIEW OF SPILLWAY FROM ACROSS THE POND.

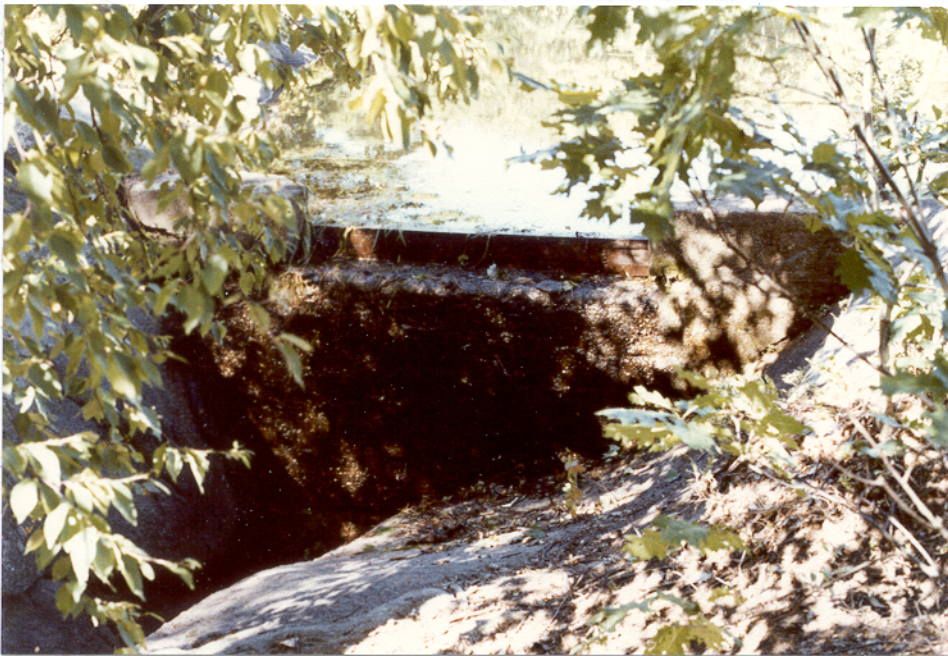
- b. Dam - The main spillway concrete was noted to be in good to fair condition. The surface of the concrete appears to have softened. The joints in the concrete have started to deteriorate and there is efflorescence on the left side of the structure. Seepage is occurring on the right side where the structure abuts the rock outcrop. The spillway is shown in Photo Nos. 2 and 3. The area immediately downstream of the concrete weir is a rock gorge as shown in Photo No. 4. This area has a major amount of debris present in the form of twigs, branches and young trees. There is some tree growth within the gorge itself.

3. DOWNSTREAM FACE OF SPILLWAY.

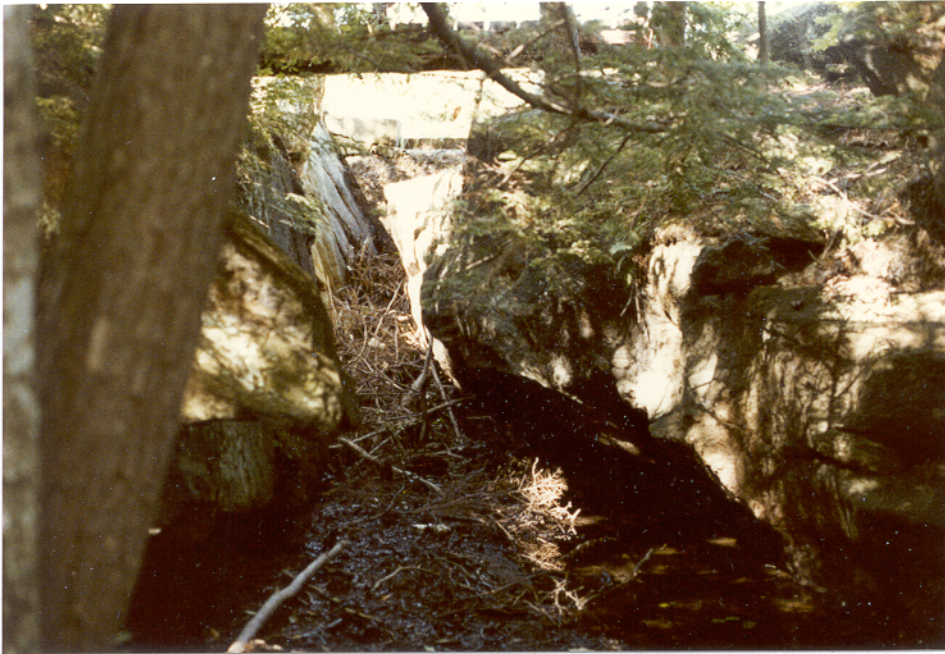
3. Discharge Channel a. Apron b. Stilling Basin c. Channel Floor d. Vegetation e. Seepage f. Obstructions g. General Struct. Condition	3. a. None b. None c. Rock gorge d. Tree in rock right side. e. Seepage from bot. of spillway concrete on left side and possibly right side. f. Clogged with brush, twigs & debris. g. Good but channel requires cleaning.

4. DOWNSTREAM CHANNEL LOOKING TOWARDS SPILLWAY.
NOTE DEBRIS BELOW SPILLWAY WEIR.

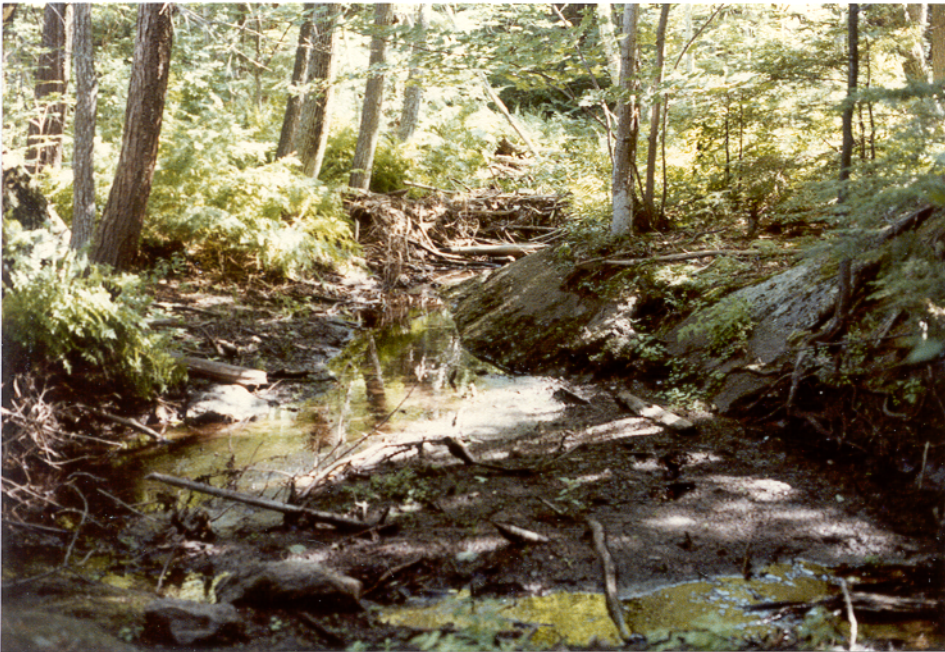
5. LOOKING DOWNSTREAM FROM ROCK GORGE BELOW SPILLWAY.

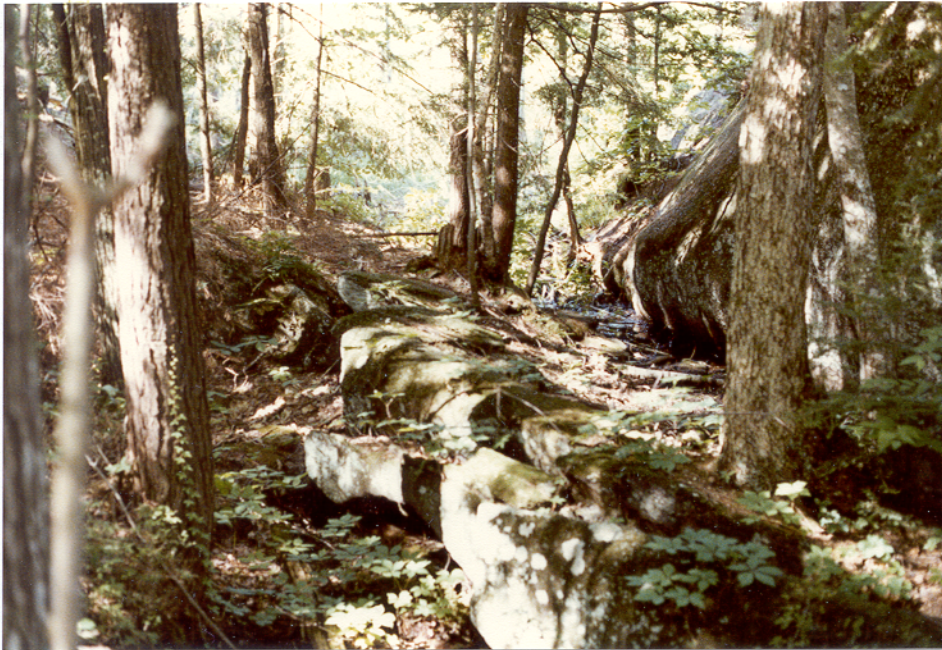
While there was ponded water and slight flow on the downstream side of the westerly dike (Dike 1), there was no indication of piping or active erosion along the dike. Therefore, the apparent seepage is not considered to pose an immediate hazard to the stability of the westerly dike. It should also be noted that the dike embankments are only a few feet high. Where there is seepage at Dike 1, the nearly equal upstream and downstream water levels result in a low hydraulic gradient through the embankment.

6. OVERLAND SEEPAGE FROM LAGOON BEHIND DIKE NO. 1 TO CHANNEL DOWNSTREAM OF SPILLWAY, VIEW IS LOOKING SOUTH AT END OF ROCK GORGE BELOW SPILLWAY.

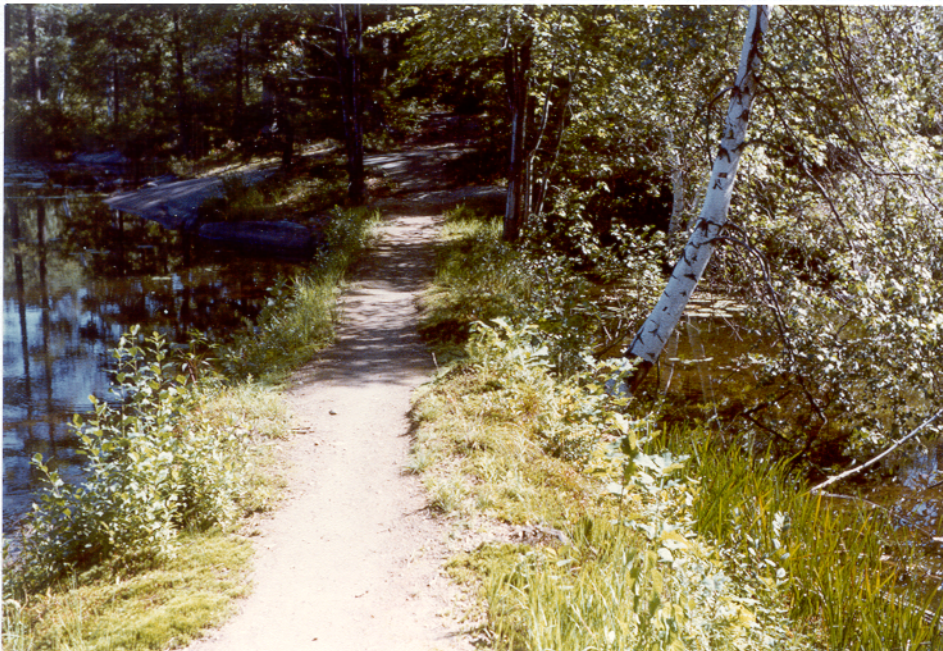
7. CREST OF DIKE NO. 1.

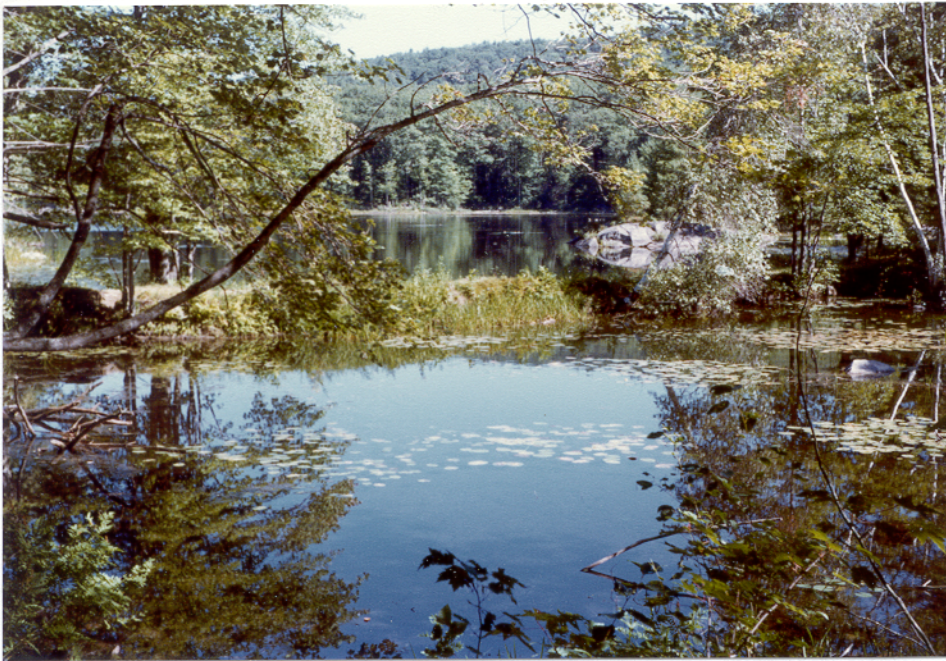
8. DOWNSTREAM FACE OF DIKE NO. 1 AND LAGOON BEHIND DIKE.

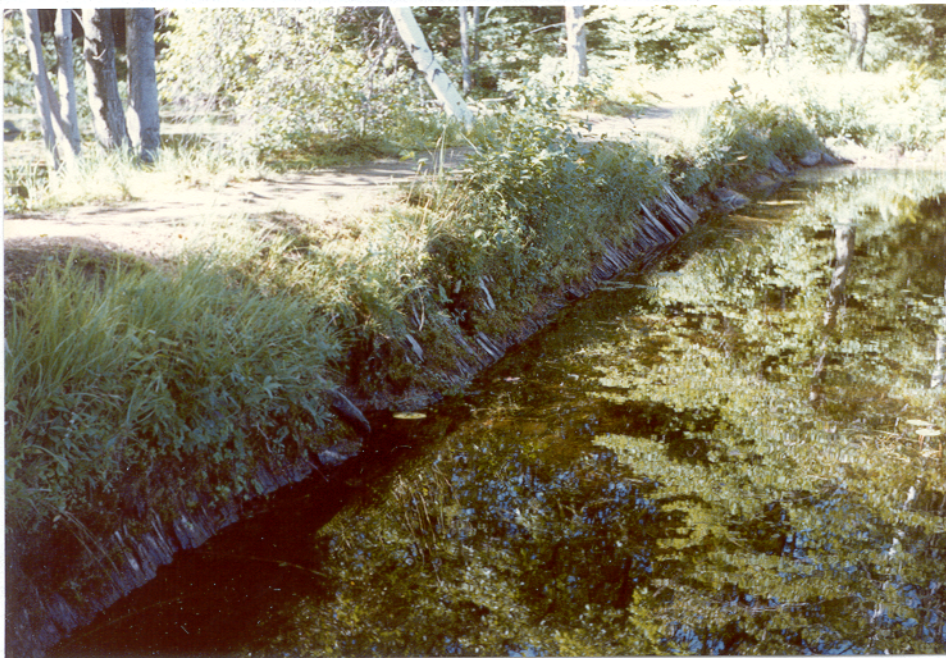
CHECK LIST	CONDITION
1. Upstream Slope a. Vegetation b. Sloughing or Erosion c. Rock Slope Protection - Riprap Failures d. Animal Burrows	1. a. Grass, weeds, ferns b. Steep, w/rotted boards & local few inches earth overhang. c. No riprap (boards along approx. 40' of length) d. None observed

9. UPSTREAM FACE OF DIKE NO. 1 SHOWING DECAYED TIMBER.

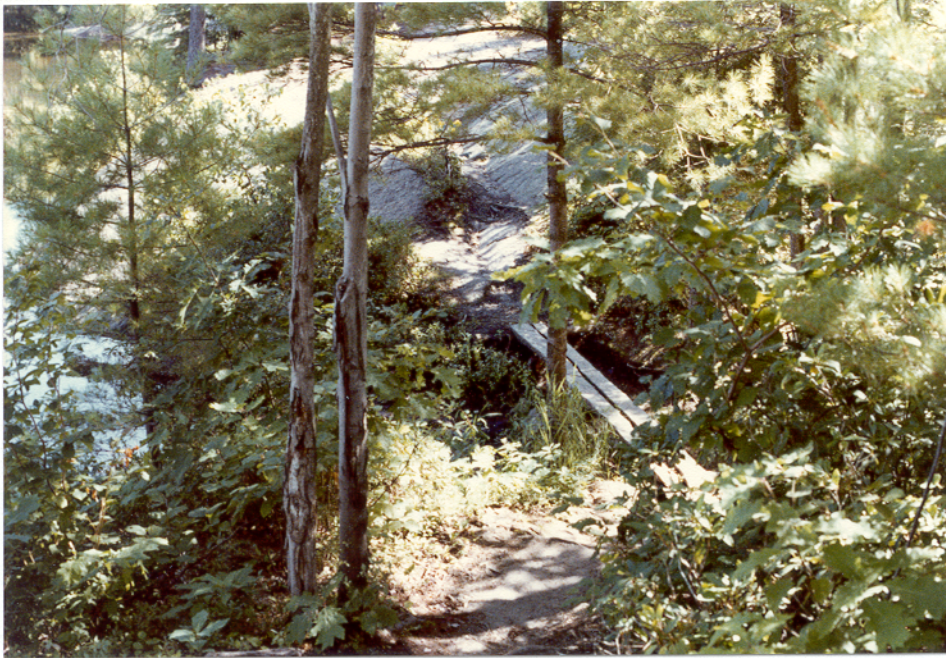
Seepage was present at Dike No. 2 during the time of the site examination. Several planks had been placed in the area to allow foot traffic over the wet loose ground. Dike No. 2 is shown in Photo No. 10.

10. OVERVIEW OF DIKE NO. 2 FROM ITS RIGHT ABUTMENT.

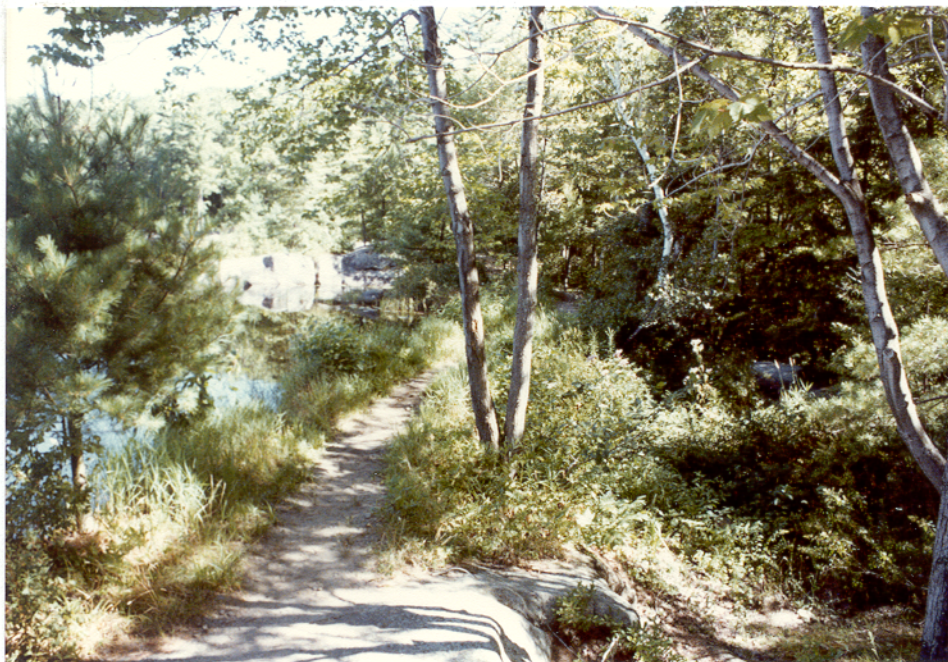
11. CREST OF DIKE NO. 3.

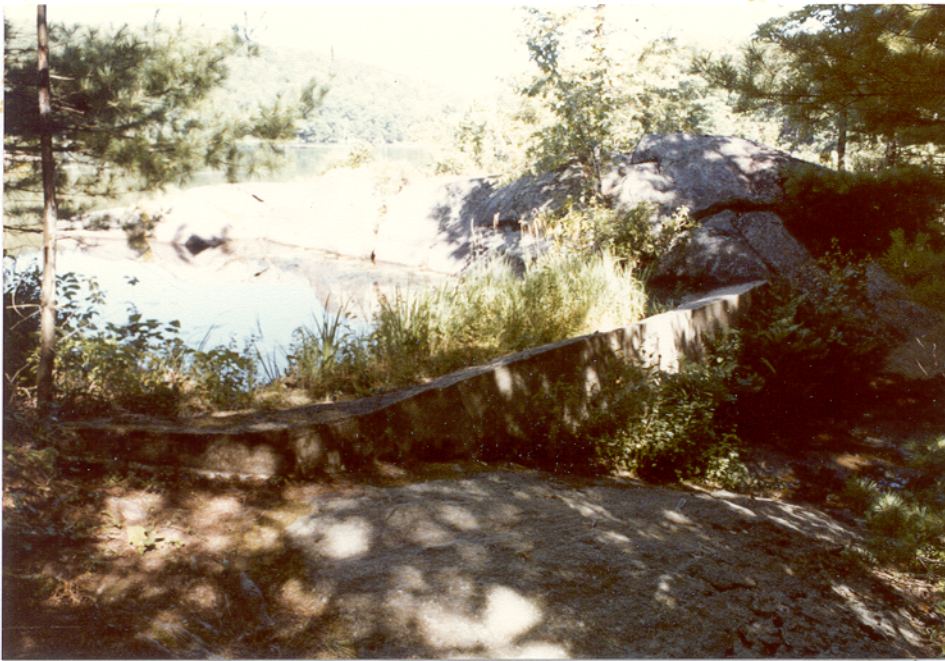
The auxillary spillway concrete was found to be in good condition. A vertical crack was observed on the right side of the wall and several spalls were present on the downstream face. Seepage was observed at the base of the wall. A small reinforcing bar projects 3 inches above the crest of this structure. No special import is given to the projecting reinforcing bar. The auxillary spillway is shown in Photo No. 12.

12. DOWNSTREAM FACE OF AUXILARY SPILLWAY.

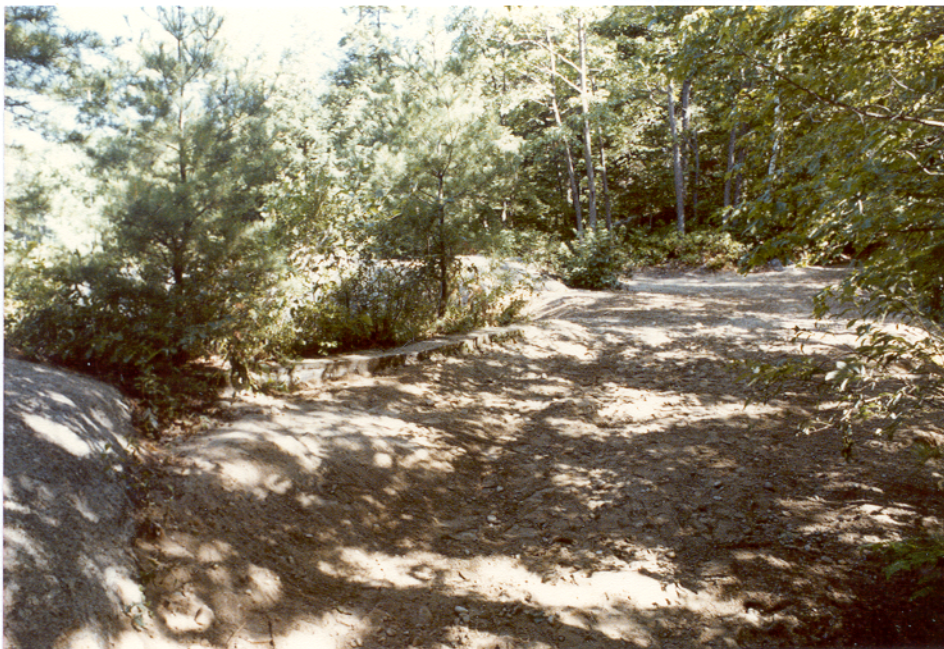
The remains of what appears to be an old concrete dam is incorporated in Dike No. 4 on the right hand side upstream face. This wall extends between two rock outcrops. The concrete has horizontal and vertical fractures in it. Although the concrete is in poor condition, its present usage appears to be as upstream face protection for this portion of the dike. The condition of the concrete therefore, has no particular rating at this location. The wall at Dike No. 4 is shown in Photo No. 13.

5. Wall a. General Struct. Condition	5. a. Concrete appears to be same vintage as auxillary spillway concrete. Spans between rock outcrops. 3 large vertical cracks present. Structure appears to be in poor structural condition but present usage appears to be upstream face protection.

13. CREST OF DIKE NO. 4 SHOWING FRACTURED CONCRETE WALL AT UPSTREAM FACE AND FRESHLY PLACED FILL BEHIND TO FORM A NEW CREST.
